Manhole Inspection Summary

Manhole # S07CC2017MH

Location Address: **2605 STEELE RD** Cross Street: **BERKELEY AVE**

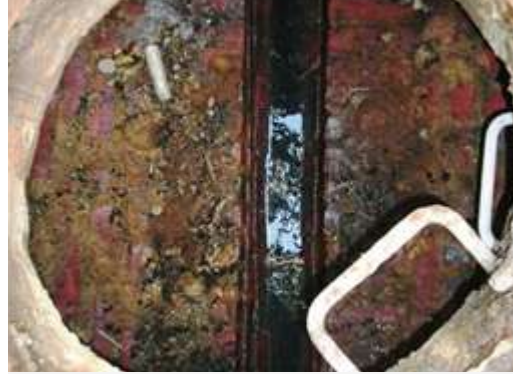
Top View

Bench ☒ Exists Material: **Brick** ☐ Parged ☒ **Debris** (not Condition related)
Condition: ☒ Sound ☐ Cracked ☐ Root Intrusion ☐ Deteriorated ☐ Leaks ☐ Debris

Surcharge ☒ **Evidence Of Surcharge** Depth: **1** (ft.) ☐ Active Surcharge Present

Evidence of surcharge - Bench debris.

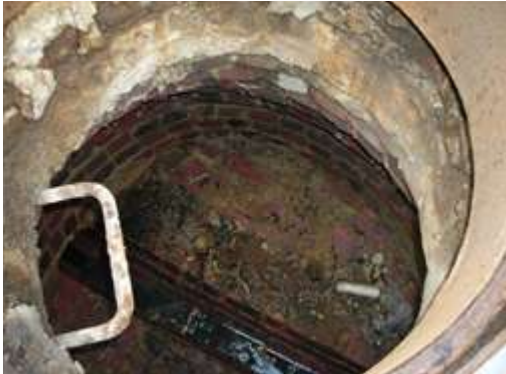
Defect

Frame Offset: **0** (in.) Condition: ☐ Sound ☐ Cracked ☒ **Leaks**

Chimney / Frame Adjustment ☒ Exists Material: **Brick** ☐ Parged Height: **16** (in.)
Condition: ☐ Sound ☐ Cracked ☐ Root Intrusion ☐ Loose Brick ☒ **Deteriorated**
Infiltration: ☐ None ☒ **Joint** ☐ Cracks ☒ **Mortar** ☐ Roots ☐ Wall

Corbel Material: **Brick** ☐ Parged Type: **Concentric/Eccentric**
Condition: ☒ Sound ☐ Cracked ☐ Root Intrusion ☐ Loose Brick ☐ Deteriorated
Infiltration: ☐ None ☐ Joint ☐ Cracks ☒ **Mortar** ☐ Roots ☒ **Wall**

Frame leaks. Adjustment deterioration and infiltration. Corbel infiltration.

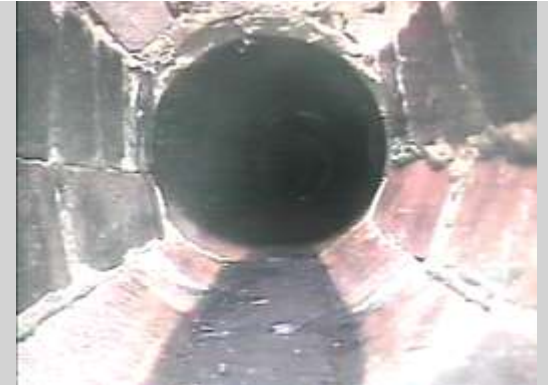
8 in. Circular Gravity Sewer Pipe Out @ 12 O'Clock

Pipe Material: **Clay** ☐ Pipe Lined

Invert Depth: **5.53** (ft.) Flow Characteristics: **None**

Infiltration: **None** Pipe Seal Cond: **Unknown**

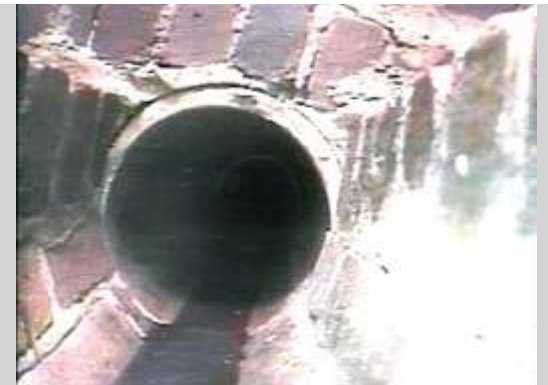
8 in. Circular Gravity Sewer Pipe In @ 6 O'Clock

Pipe Material: **Clay** ☐ Pipe Lined

Invert Depth: **5.52** (ft.) Flow Characteristics: **None**

Infiltration: **None** Pipe Seal Cond: **Unknown**
